RCRA SITE SAMPLING REPORT

FORMER CW PROCESS COMPANY;
AKA WAYNE MANUFACTURING
(EPA ID No. IAD005277256)
Cedar Rapids, Iowa

IN SUPPORT OF
THE U.S. ENVIRONMENTAL PROTECTION AGENCY REGION 7

May 20, 2011

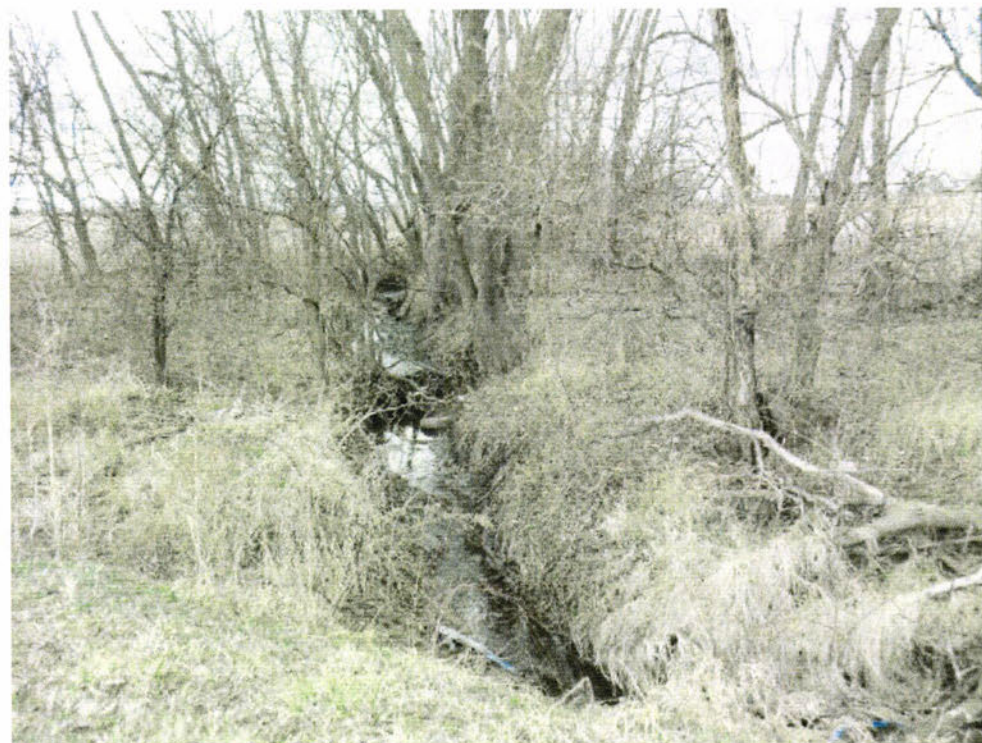
Photo 32; April 4, 2011, 1607; Photographer: John Dixon; Facing N.
View of the western fork of the unnamed tributary west of the former CW Process site (view from 33rd Avenue). Sampling Location 002.

- Location 002 (surface water and sediment) was also originally sited in the drainageway running southwest from the former CW site. It was noted that no surface water was present in this drainageway. It was also noted that the unnamed tributary west of the West Field forked near 33rd Avenue. Location 004 was sited on the east fork of this tributary. Location 002 was moved to the west fork of this unnamed tributary.

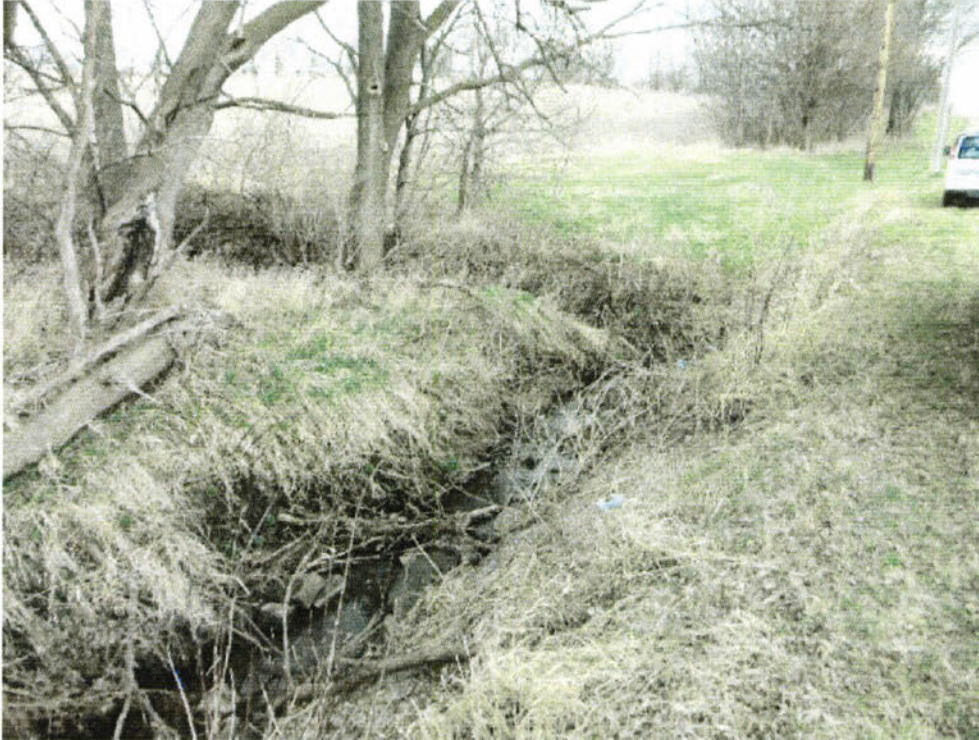
Photo 33; April 4, 2011, 1607; Photographer: John Dixon; Facing E.
View of the junction of western fork and eastern fork of the unnamed tributary west of the former CW Process site. Forks join together at the bend prior to crossing 33rd Avenue and flowing offsite to the right.

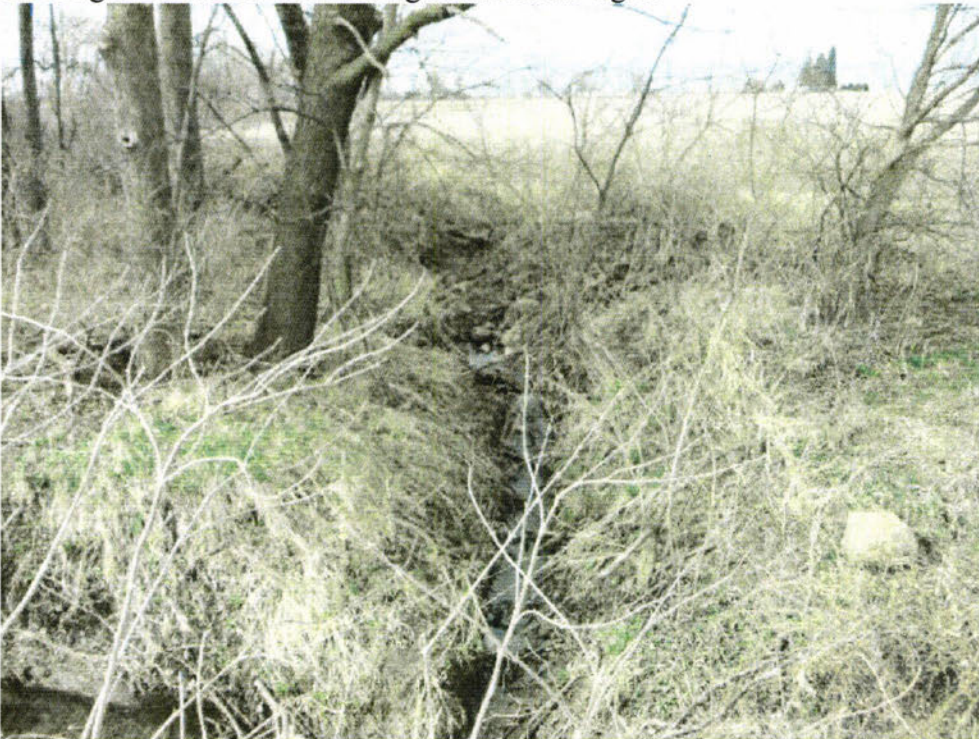
Photo 34; April 4, 2011, 1622; Photographer: John Dixon; Facing N.
View of the eastern fork of the unnamed tributary west of the former CW Process site. Sampling Location 004 near the northern section of this fork.

Significant cyanide concentrations were detected from the Location 004 (downgradient location) sample and its duplicate sample. Location 004 is described in Table 1 as the east fork of the unnamed tributary downgradient and west of the CW Process source area. The primary channel of the unnamed tributary is identified as the west fork in Table 1. The east fork (where Location 004 was sited) is not directly connected to the upgradient portion of the tributary, but appears to be fed by surface water flows from the West Field and surfacing groundwater from below the West Field (see photographs 34 and 35 in Appendix F). Location 005 is directly downgradient of the east and west forks of the unnamed tributary, following their merger. The cyanide detections at Locations 004 and 005 are discussed in Section 5.2 of this report.

The east fork of the unnamed tributary downgradient and west of the CW Process source area appears to be fed by surface water runoff from the West Field and groundwater surfacing from below the West Field. At the time of the Site Sampling Visit, groundwater seepage was the sole source of the water in this fork (see photographs 34 and 35 in Appendix F). Location 004 was sited immediately below the source of the groundwater seepage.

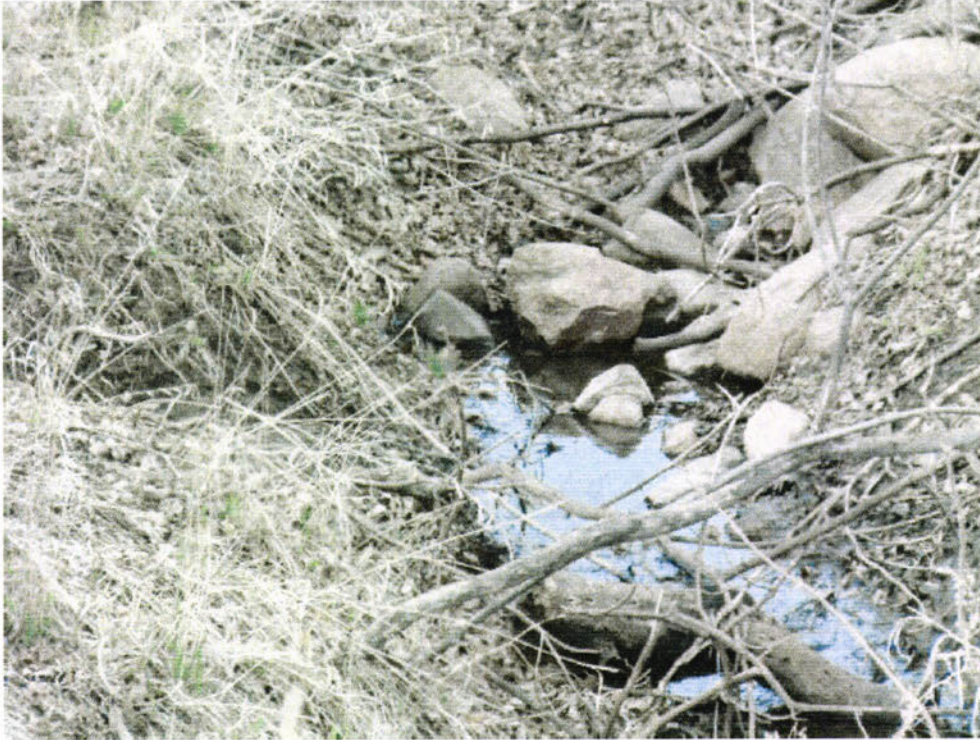
Photo 35; April 4, 2011, 1623; Photographer: John Dixon; Facing N.
View of the “spring-like” emergence of the eastern fork of the unnamed tributary west of the former CW Process site. Sampling Location 004 is immediately downstream of the fork’s emergence.
